# CC430F6126 Device Erratasheet

## 1 Functional Errata Revision History

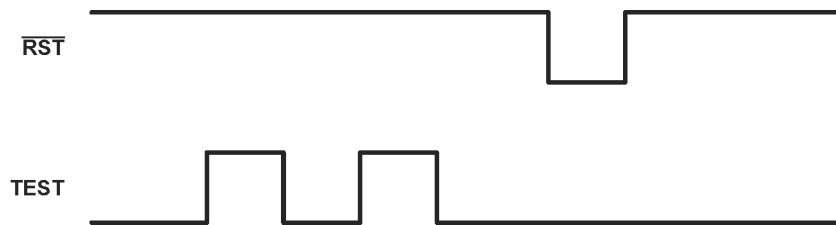
<b>Category</b>	Software in ROM
<b>Function</b>	BSL does not exit to application code
<b>Description</b>	The methods used to exit the BSL per MSP430 Programming Via the Bootstrap Loader (SLAU319) are invalid.
<b>Workaround</b>	To exit the BSL one of the following methods must be used. - A Power cycle or - Toggle the TEST pin twice when nRST is high and after 50us pull nRST low.

Note: This toggling of TEST pins is not subject to timing constraints. The appropriate level transitions on TEST pin, followed by a RST pulse after 50us, are sufficient to trigger an exit from BSL mode.
