MSP430F2617 Device Erratasheet

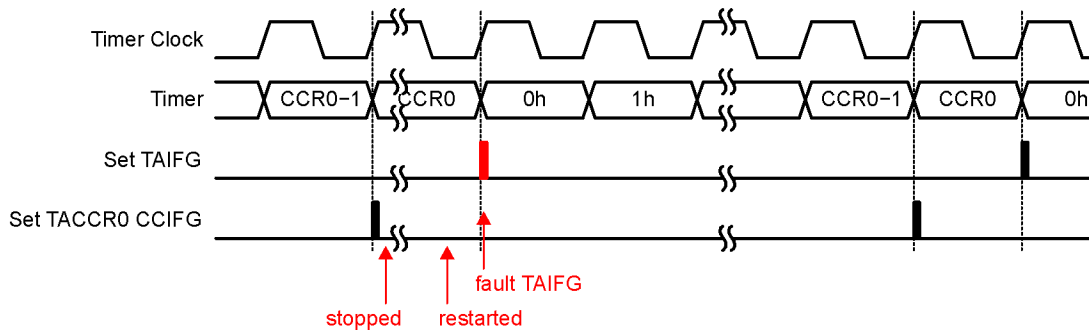
TA21 *TIMER_A Module*

Function TAIFG Flag is erroneously set after Timer A restarts in Up Mode

Description In Up Mode, the TAIFG flag should only be set when the timer counts from TACCR0 to zero. However, if the Timer A is stopped at TAR = TACCR0, then cleared (TAR=0) by setting the TACLK bit, and finally restarted in Up Mode, the next rising edge of the TACLK will erroneously set the TAIFG flag.

Workaround None.
