MSP430F5333 Device Erratasheet

1 Functional Errata Revision History

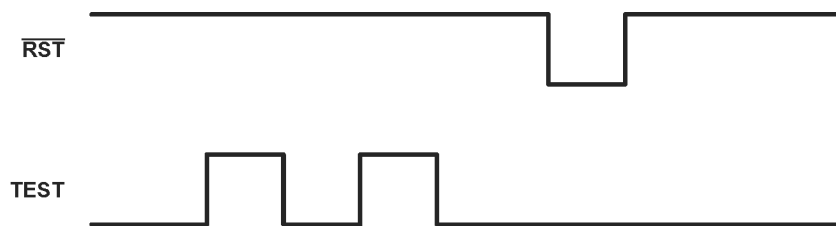
JTAG20 **JTAG Module**

Function BSL does not exit to application code

Description The methods used to exit the BSL per MSP430 Programming Via the Bootstrap Loader ([SLAU319](#)) are invalid.

Workaround To exit the BSL one of the following methods must be used.

- A Power cycle
- or
- Toggle the TEST pin twice when nRST is high and after 50us pull nRST low.

Note: This toggling of TEST pins is not subject to timing constraints. The appropriate level transitions on TEST pin, followed by a RST pulse after 50us, are sufficient to trigger an exit from BSL mode.
