**TMS320C6414T, TMS320C6415T,
TMS320C6416T
Digital Signal Processors
Silicon Errata**

Silicon Revision 2.0, 1.0

SPRZ216H
December 2003
Revised July 2006

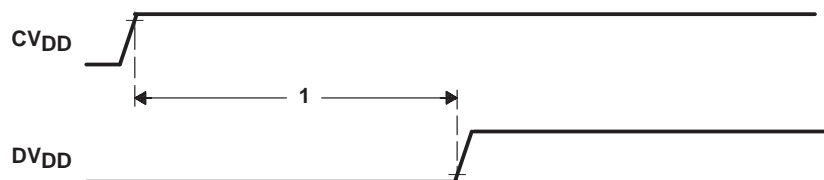
Figure 2. Power-On Sequence Timing

When DV_{DD} powers up before CV_{DD}, the PCI/HPI I/O buffers can be initialized incorrectly – causing them to be stuck in a Hi-Z condition. This can result in incorrect data on the bus, deadlocked interface or other undesirable operation.

- Power up the CV_{DD} supply before the DV_{DD} supply [see timing requirements for power-on sequence table and Figure 2] or
- Do not use the PCI and/or HPI peripherals. Do not use GP[15:9] as outputs.

NO.		-600, -720, -850, -1G		UNIT
		MIN	MAX	
1	t _d (CV _{DD} -DV _{DD}) Delay time, CV _{DD} supply ready to DV _{DD} supply ramp start	0.5	200	ms
