TMS320C6678
Multicore Fixed and Floating-Point Digital
Signal Processor
Silicon Revision 1.0, 2.0

Silicon Errata

Literature Number: SPRZ334H
January 2011–Revised June 2015

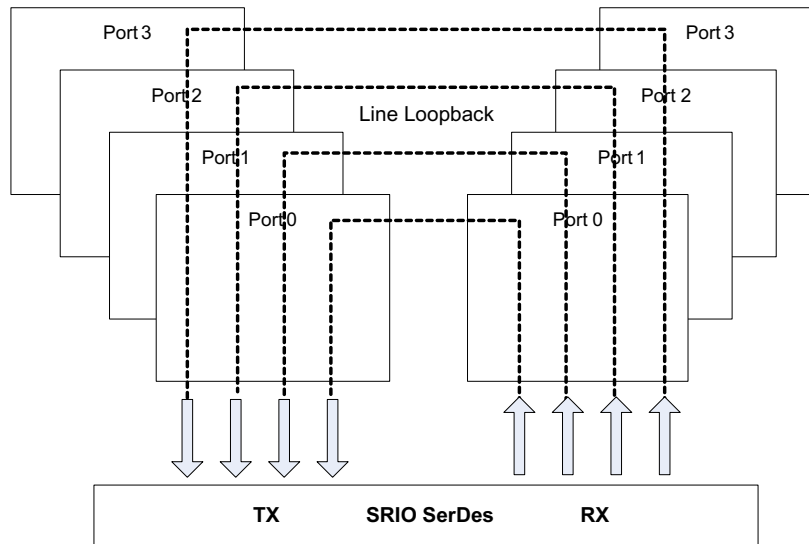
Figure 5. SRIO SerDes in Loopback Mode

Details: The SRIO physical layer is configured in line loopback mode on a per-port basis, by setting the LLB_EN bit in PLM_SP(n)_IMP_SPEC_CTL register. In line-loopback mode, the data from the SerDes receiver is looped back to the SerDes transmitter. [Figure 5](#) shows the line loopback from SerDes RX to SerDes TX:

The port does not provide any clock compensation when line loopback is enabled. The transmit clock must be externally synchronized with the receive clock. There is only a small FIFO that can compensate for PLL jitter or wander. Hence, correct operation of line loopback requires that the link partners use the same reference clock for the SRIO physical layer, in order to avoid overruns or underruns due to clock frequency mismatch between the link partners. As a result, line loopback mode is generally restricted to validation and qualification of board signal integrity in a lab environment.
