TMS320C6746 Fixed- and Floating-Point DSP Silicon Revisions 2.3, 2.1, 2.0, 1.1 and 1.0

Silicon Errata

Literature Number: SPRZ304H
June 2009–Revised March 2014

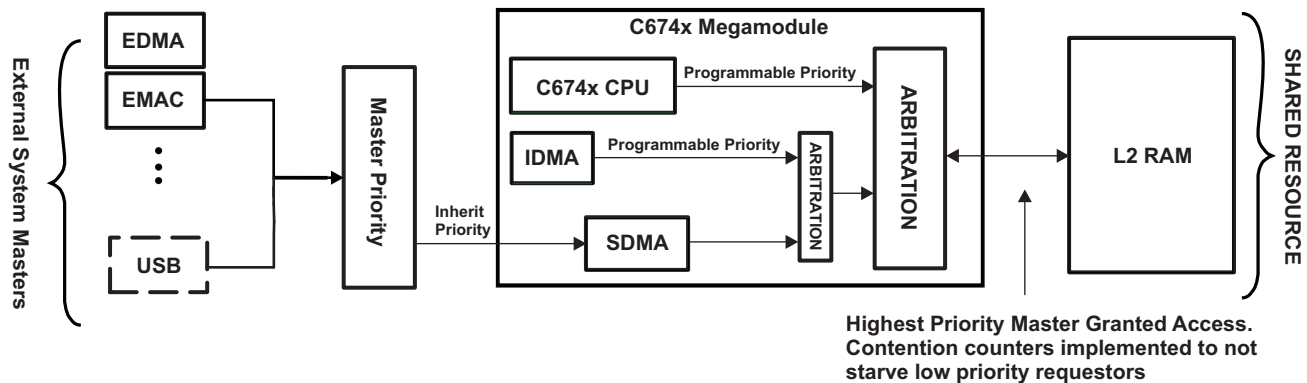
Figure 3. Priority Arbitration Scheme for L2 RAM

Ideally, the BWM arbitration will grant equal L2 bandwidth between equal priority DMA and CPU requests. Instead, when equal priority DMA and CPU requests arrive at the BWM, bandwidth is always granted in favor of the CPU over DMA. In the case of successive CPU requests, it is possible for the CPU to block all DMA requests until CPU traffic subsides. Additionally, some command logic in the BWM uses priority level 7, which can also result in SDMA stalls when the CPU is also programmed to priority level 7. [Figure 3](#) shows a high level diagram of the arbitration scheme used for L2 RAM requests.

Workaround(s) Configure DMA and CPU requests to different priority levels. There is no penalty for setting the IDMA and SDMA priorities equal to each other.

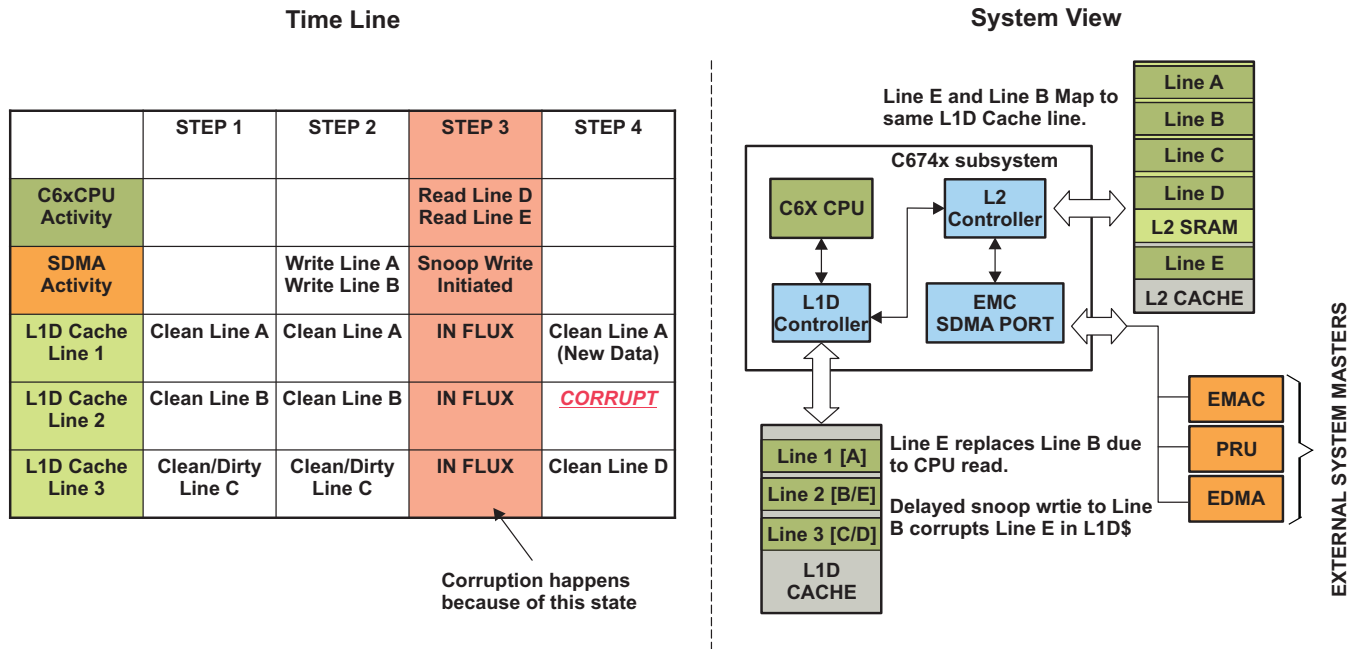
Figure 4. Example of L1D Cache Corruption

An L1D cache-line corruption event occurs when all of the conditions in the following steps are met (see [Figure 4](#)):

- Line E in L2 cache is read as a cache hit. Line E is destined to replace Line 2 in L1D Cache, which also has a snoop write pending for the updated Line B content.

- Line D in L2 SRAM is read. Line D will replace Line 3 in L1D cache.
4. When the snoop write operation completes, Line 2 in L1D cache now contains the updated L2 SRAM Line B data instead of the L2 cache Line E data.

The correct behavior would have been to kill the pending snoop write initiated to update L1D cache Line 2 with the updated L2 SRAM Line B data in Step 3. The L1D cache should have evicted Line B and replaced it with Line E data. Instead, the snoop write operation continues and does not complete until after the L1D cache Line 2 has already been replaced with L2 cache Line E data. The snoop write instruction overwrites the L1D cache Line 2 (containing L2 cache Line E data) with the updated L2 SRAM Line B data.

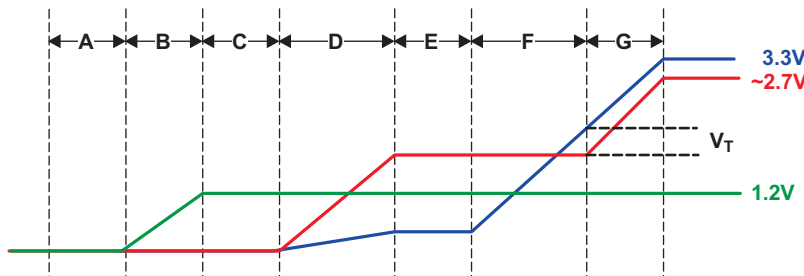
Figure 6. Faulty power-supply ramp

The behavior is the same until zone G. When the DVDD3318_x supply exceeds DVDD18 by a transistor V_T, the DVDD18 supply begins to be pulled up by the DVDD3318_x supply and follows the DVDD3318_x supply by DVDD3318_x - V_T. Since the DVDD18 supply is often connected to other 1.8V supplies in the design, these other supplies can be pulled up also.

The condition occurs because the dual-voltage IO buffers have voltage detection circuitry that monitors DVDD3318_x during reset and determines whether the applied supply voltage is 1.8V or 3.3V. This detection circuitry then configures the IOs to operate at the appropriate voltage. As the DVDD3318_x supply ramps, there is a small range near DVDD18 + V_T where the voltage detection circuit finds the state indeterminate and briefly turns on circuitry associated with both voltage options creating a current path between them. This current path can cause the DVDD18 supply to be pulled up. The mechanism for this behavior is explained below:

1. Design simulation has indicated that under the worst-case process/voltage/temperature conditions the maximum leakage current into the DVDD18 supply due to this phenomenon will be 140 mA (the 140 mA is a cumulative current generated by all of the dual-voltage IOs). So this error state can be prevented by ensuring that the load on the DVDD18 supply during the DVDD13318_x supply ramp exceeds 140 mA. This can be achieved by any combination of the following as long as they cumulatively produce >140 mA load on DVDD18 during the DVDD3318_x ramp period:

- (a) Maintain sufficient bulk capacitance on the DVDD18 supply such that the charging current for these capacitors provides all or part of the required >140 mA. Bulk capacitance in this context means the total capacitance seen by the DVDD18 supply (filter capacitors, bypass capacitors, etc.). Capacitor charging current is defined as $I = C \cdot (dV/dt)$. So the ramp rate of the DVDD3318_x supply and the total bulk capacitance on the DVDD18 supply can be used to calculate the current produced. This solution provides additional power supply filtering and little current leakage after the supplies are ramped (depending on the type of capacitors used).

2. Choose a regulator for the DVDD18 supply (or grouped 1.8V supplies) that is capable of actively regulating voltage up and down. Many high-efficiency switching regulators switch current into the load only when the voltage needs to be raised and rely on the load to pulldown the current. In this error condition, a regulator of this type will not be able to compensate for the leakage current described above. Synchronous buck regulators use external inductance to pulldown the regulated voltage when necessary.

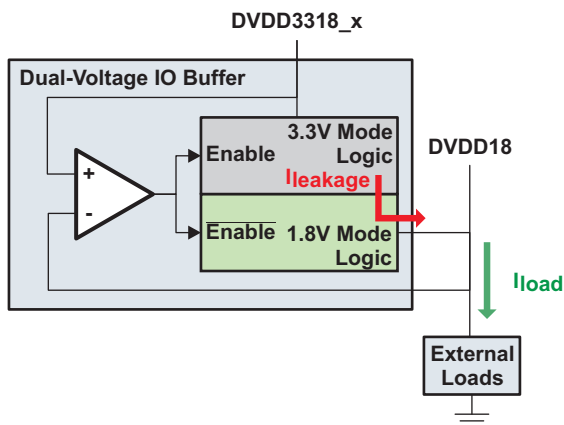
Figure 8. Error State of the IO buffer during Zone G

Error State of the IO buffer during Zone G:

As DVDD3318_x exceeds DVDD18+V_T, some of the circuitry across the boundary of the two voltage domains will turn on and causes a leakage current (in red) to flow between the two voltage domains. This current pulls up the DVDD18 supply unless the power source providing that supply can oppose it or unless the load current is strong enough to counteract it.

If DVDD18 continues to rise as DVDD3318_x ramps, the comparator never sees enough difference between the two supplies to switch to 3.3V mode.

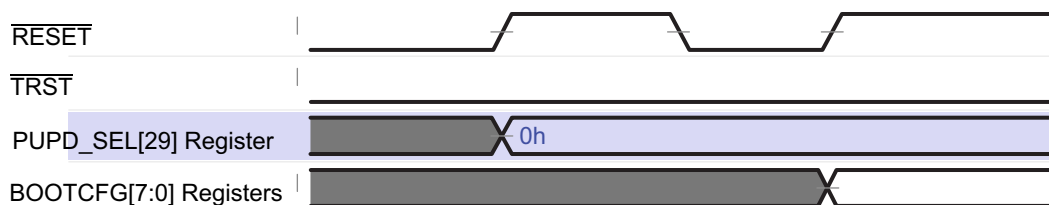
Figure 10. Initialization of PUPD_SEL[29] and BOOTCFG[7:0] Registers with Weak or No External Pull Resistors on BOOT[7:0] Pins

Internal pullups being enabled on the BOOT[7:0] pins may result in boot failures. If weak external pulldown resistors are used on the PCB to select the boot mode, they may not be able to overpower the internal pullups. This can result in the wrong boot mode being latched in the BOOTCFG[7:0] register when coming out of Reset.

Once the device is out of Reset, the PUPD_SEL[29] register is initialized, and the internal pulldown resistors for the BOOT[7:0] pins are all enabled. Issuing a second Power-On Reset (\overline{POR}) results in the intended boot mode being latched, since the pins are internally pulled down as expected.

Figure 10 shows the behavior of the PUPD_SEL[29] register before and after reset. Assuming weak or no external pull resistors are on the BOOT[7:0] pins, the BOOTCFG register will latch the unknown values after the device initially comes out of Reset. Note that, TRST **must** always be low in order to issue a POR and latch the boot pin values -- the boot pins are not latched after a Warm Reset.

Section 4, *Device Operating Conditions*, of the device datasheet shows the electrical characteristics information which can be used to calculate the maximum external pull resistance required. The value is dependent on the DVDD3318_C I/O supply level.

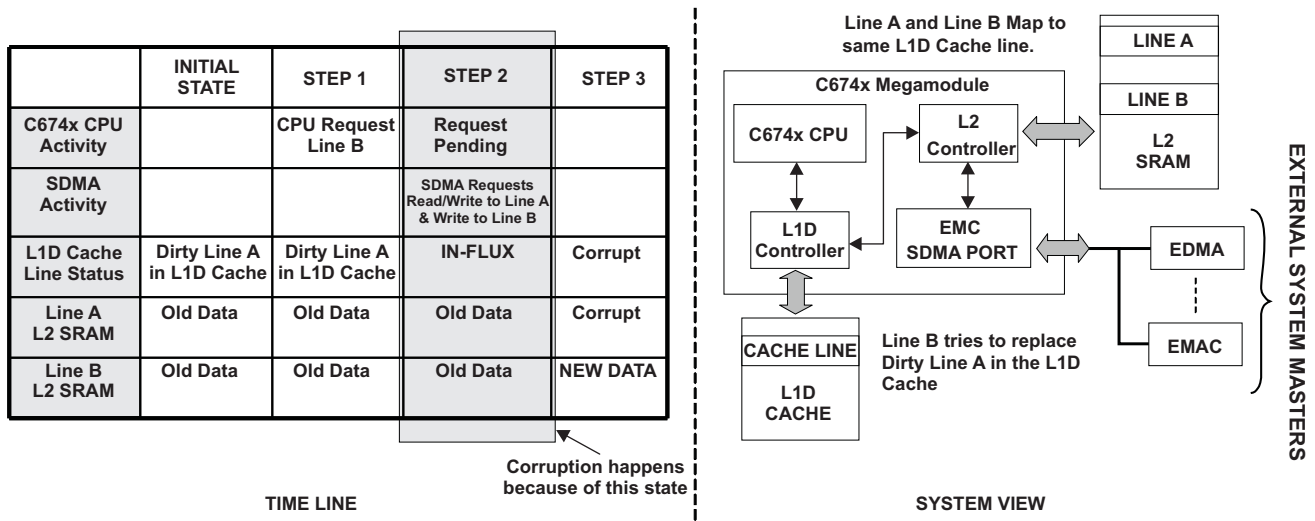
Figure 13. Example of L1D Cache and L2 RAM Corruption

An L1D cache-line corruption event occurs when all of the following conditions are met:

1. L1D cache evicts a dirty line (Line A) while allocating a new line (Line B) in the same set/way (cache Lines A and B consist of 64-bytes each). In order for this to happen, the following will have taken place:
 - (a) Line A was previously read by CPU because L1D is a read-allocate cache,
 - (b) Line A is dirty because its value was modified by CPU, and
 - (c) Line B is read by CPU
2. Both Line A and Line B are associated with L2 RAM, and
3. While the original L1D victim write-back from condition (1) is in progress, the SDMA performs both:
 - (a) a read or write operation to Line A in L2 RAM and
 - (b) a write operation to Line B in L2 RAM.

If all of the above conditions are met, the L2 RAM data associated with the Line A victim writeback will become corrupt. Additionally, the Line B data originating from the SDMA write will also become corrupt in L1D cache. [Figure 13](#) shows an example scenario of L1D cache and L2 RAM corruption.

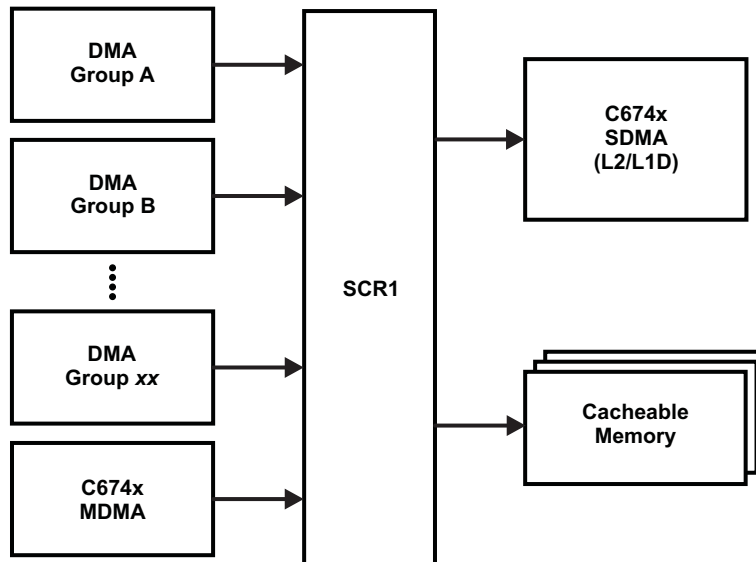
Figure 15. SCR1 System Interconnect

Step 2: The DSP's SDMA asserts itself as not ready and is unable to accept the write data from Step 1, and a cache line writeback is initiated from DSP memory to the same cacheable memory from Step 1. The cache line writeback command also passes through SCR1.

With the above scenario, it is possible for SCR1 to order the write commands from Step 1 in front of the write commands from Step 2. Due to the MDMA/SDMA blocking behavior, the SDMA commands from Step 2 will be waiting for the MDMA traffic from Step 1 to finish, resulting in a deadlock situation at SCR1. [Figure 15](#) is provided for illustrative purposes and is incomplete because of simplification.
