TMS320C6678
Multicore Fixed and Floating-Point Digital
Signal Processor
Silicon Revision 1.0, 2.0

Silicon Errata

Literature Number: SPRZ334H
January 2011–Revised June 2015

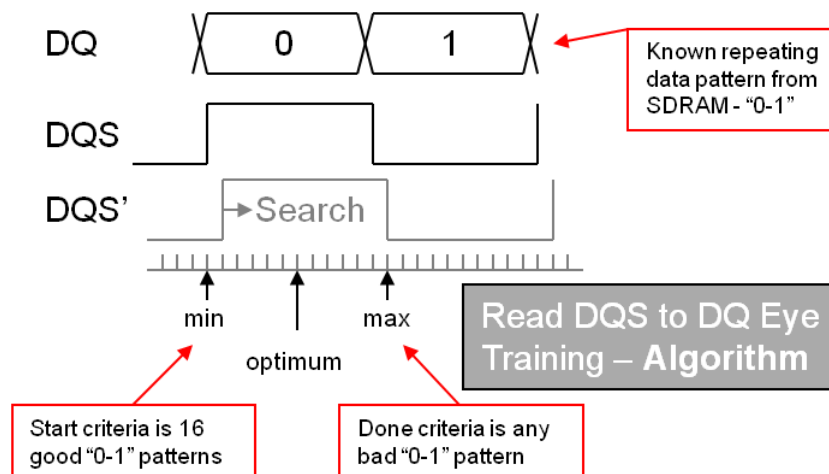
Figure 3. Read DQS to DQ Eye Training - Algorithm

As shown in [Figure 3](#), the Read Data Eye Training algorithm should correctly detect the extents of the DQ data eye. The SDRAM are put into a DQS to DQ eye training mode and read back an alternating 0, 1 pattern.

The DDR3 PHY uses this pattern to detect good or bad data being sampled by the DQS transitions. The DDR3 PHY searches by delaying DQS relative to DQ until these constraints are found.
