TMS320C6746 Fixed- and Floating-Point DSP Silicon Revisions 2.3, 2.1, 2.0, 1.1 and 1.0

Silicon Errata

Literature Number: SPRZ304H
June 2009–Revised March 2014

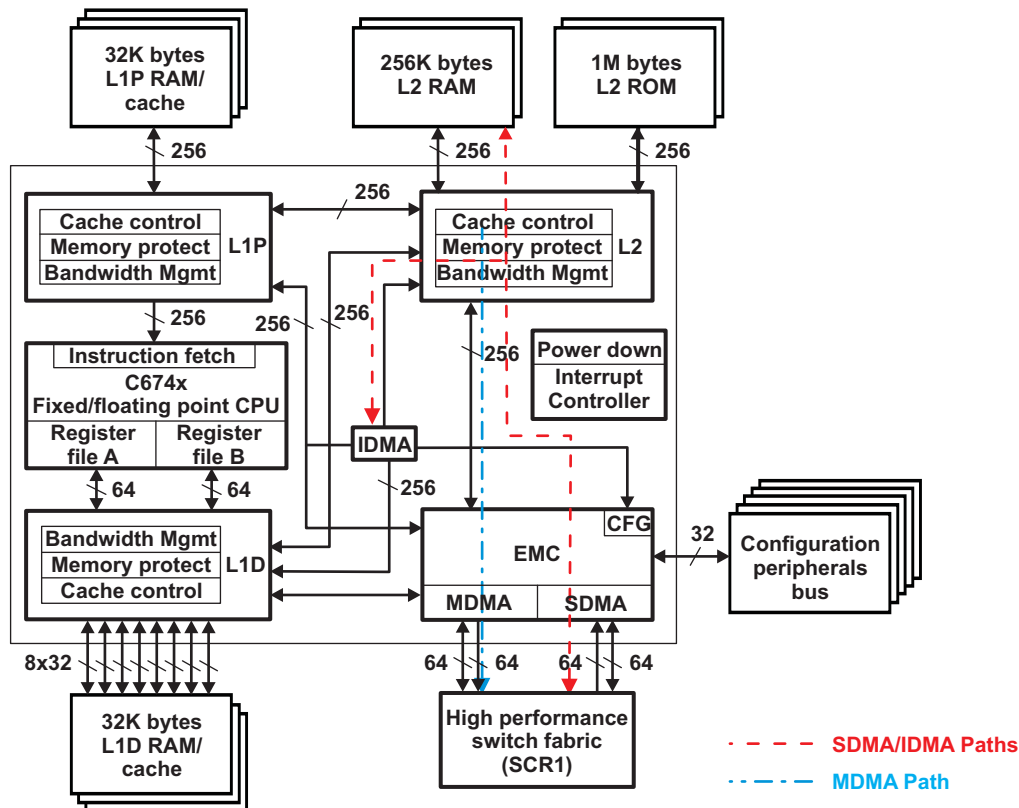
Figure 14. C674x Megamodule

Ideally, the MDMA (dashed-dotted line in [Figure 14](#)) and SDMA/IDMA paths (dashed lines in [Figure 14](#)) operate independently with minimal interference. Normally MDMA accesses may stall for extended periods of time due to expected system level delays (for example, bandwidth limitations). However, when using L2 as RAM, SDMA and IDMA accesses to L2/L1 may experience unexpected stalling in addition to the normal stalls seen by the MDMA interface. For latency-sensitive traffic, the SDMA stall can result in missing real-time deadlines. In a more severe case, the SDMA stall can produce a deadlock condition in the device. An IDMA stall cannot produce a deadlock condition.

Note: SDMA/IDMA accesses to L1P/D will not experience an unexpected stall if there are no SDMA/IDMA accesses to L2. Unexpected SDMA/IDMA stalls to L1 happen only when they are pipelined behind L2 accesses. Additionally, the deadlock scenario will be avoided if there are no SDMA accesses to L2.

Figure 14 is provided for illustrative purposes and is incomplete because of simplification. The IDMA/SDMA (dashed-lines) path could also go to L1D/L1P memories, and IDMA can go to DSP CFG peripherals. MDMA transactions can originate also from L1P or L1D through the L2 controller or directly from DSP).

The duration of the SDMA/IDMA stalls depend on the quantity/characteristics of the L1/L2 cache and the MDMA traffic in the system. Therefore, it is difficult to predict if stalling will occur and for how long.
