AWR1642 Device Errata

1 Introduction

This document describes the known exceptions to the functional and performance specifications to TI CMOS Radar Devices (AWR1642).

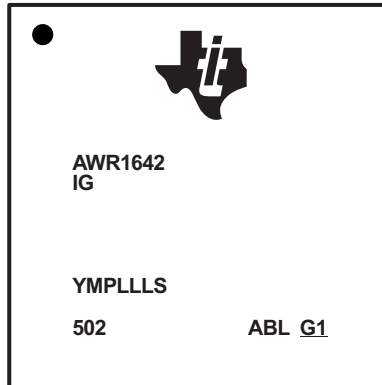
Figure 1. Example of Device Part Markings

Figure 1 shows an example of the AWR1642 Radar Device's package symbolization.

This identifying number contains the following information:

- **Line 1:** Device Number
- **Line 2:** Temperature and Security Grade
- **Line 3:** Lot Trace Code
 - YM = Year/Month Code
 - P L L L = Assembly Lot
 - S = Assembly Site Code
- **Line 4:**
 - 502 = AWR1642 Identifier
 - ABL = Package Identifier
 - G1 = "Green" Package Build (must be underlined)
