IWR1642 Device Errata

This document describes the known exceptions to the functional and performance specifications to TI CMOS Radar Devices (IWR1642).

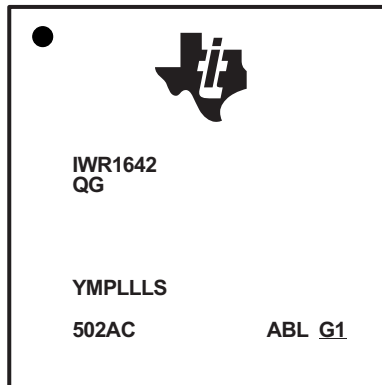
Figure 1. Example of Device Part Markings

Figure 1 shows an example of the IWR1642 Radar Device's package symbolization.

This identifying number contains the following information:

- **Line 1:** Device Number
- **Line 2:** Temperature and Security Grade
- **Line 3:** Lot Trace Code
 - YM = Year/Month Code
 - PLLL = Assembly Lot
 - S = Assembly Site Code
- **Line 4:**
 - 502AC = IWR1642 Identifier
 - ABL = Package Identifier
 - G1 = "Green" Package Build (must be underlined)
